INSTALLATION INSTRUCTIONS

PART NO. H40-401BK/H40-401RED

DUAL TANK POUCH SET

FITMENT: CAN-AM RYKER 2019-NEWER

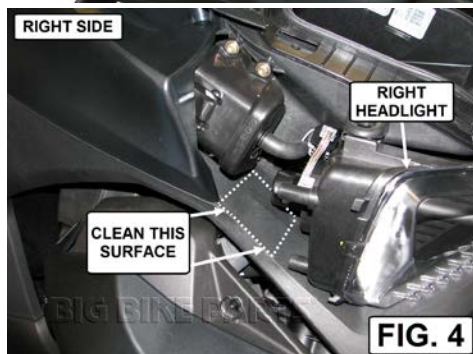
6. USING RUBBING ALCOHOL AND A LINT FREE TOWEL CLEAN THE AREA BEHIND THE RIGHT HEADLIGHT SHOWN IN FIG. 4. LET DRY.
7. USING FIG. 5 FOR REFERENCE GET THE RIGHT SIDE POUCH FROM THE PACKAGE.

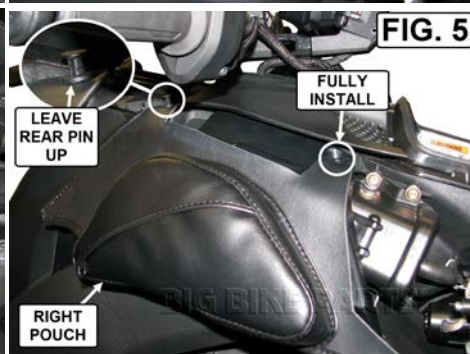
8. INSERT ONE OF THE PUSH PINS YOU REMOVED INTO THE FRONT HOLE OF THE MOUNT AND FULLY INSTALL IT (PIN IN) AS SHOWN IN FIG. 5.
9. INSERT A PUSH PIN IN THE REAR HOLE OF THE MOUNT AND INSERT IT INTO THE FARTHEST BACK HOLE BUT DO NOT PUSH IN THE PIN. SEE FIG. 5.

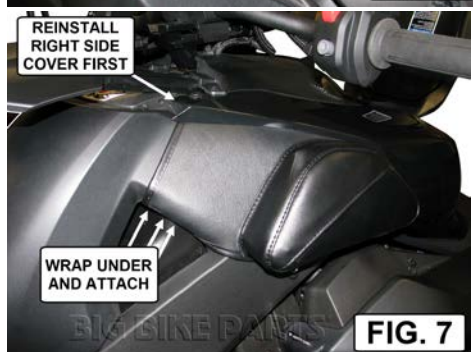
12. REMOVE THE MASKING FROM THE ADHESIVE ON THE REAR OF THE MOUNT.
13. PULL THE REAR TIGHT AND WRAP IT AROUND THE PANEL AS SHOWN IN FIG. 7. PRESS FIRMLY ON THE ATTACHMENT AREA TO HELP SET THE ADHESIVE.
